East Bethel Water Reclamation Facility (WRF) Performance Update

Environment Committee: October 25, 2022

## East Bethel Demonstration

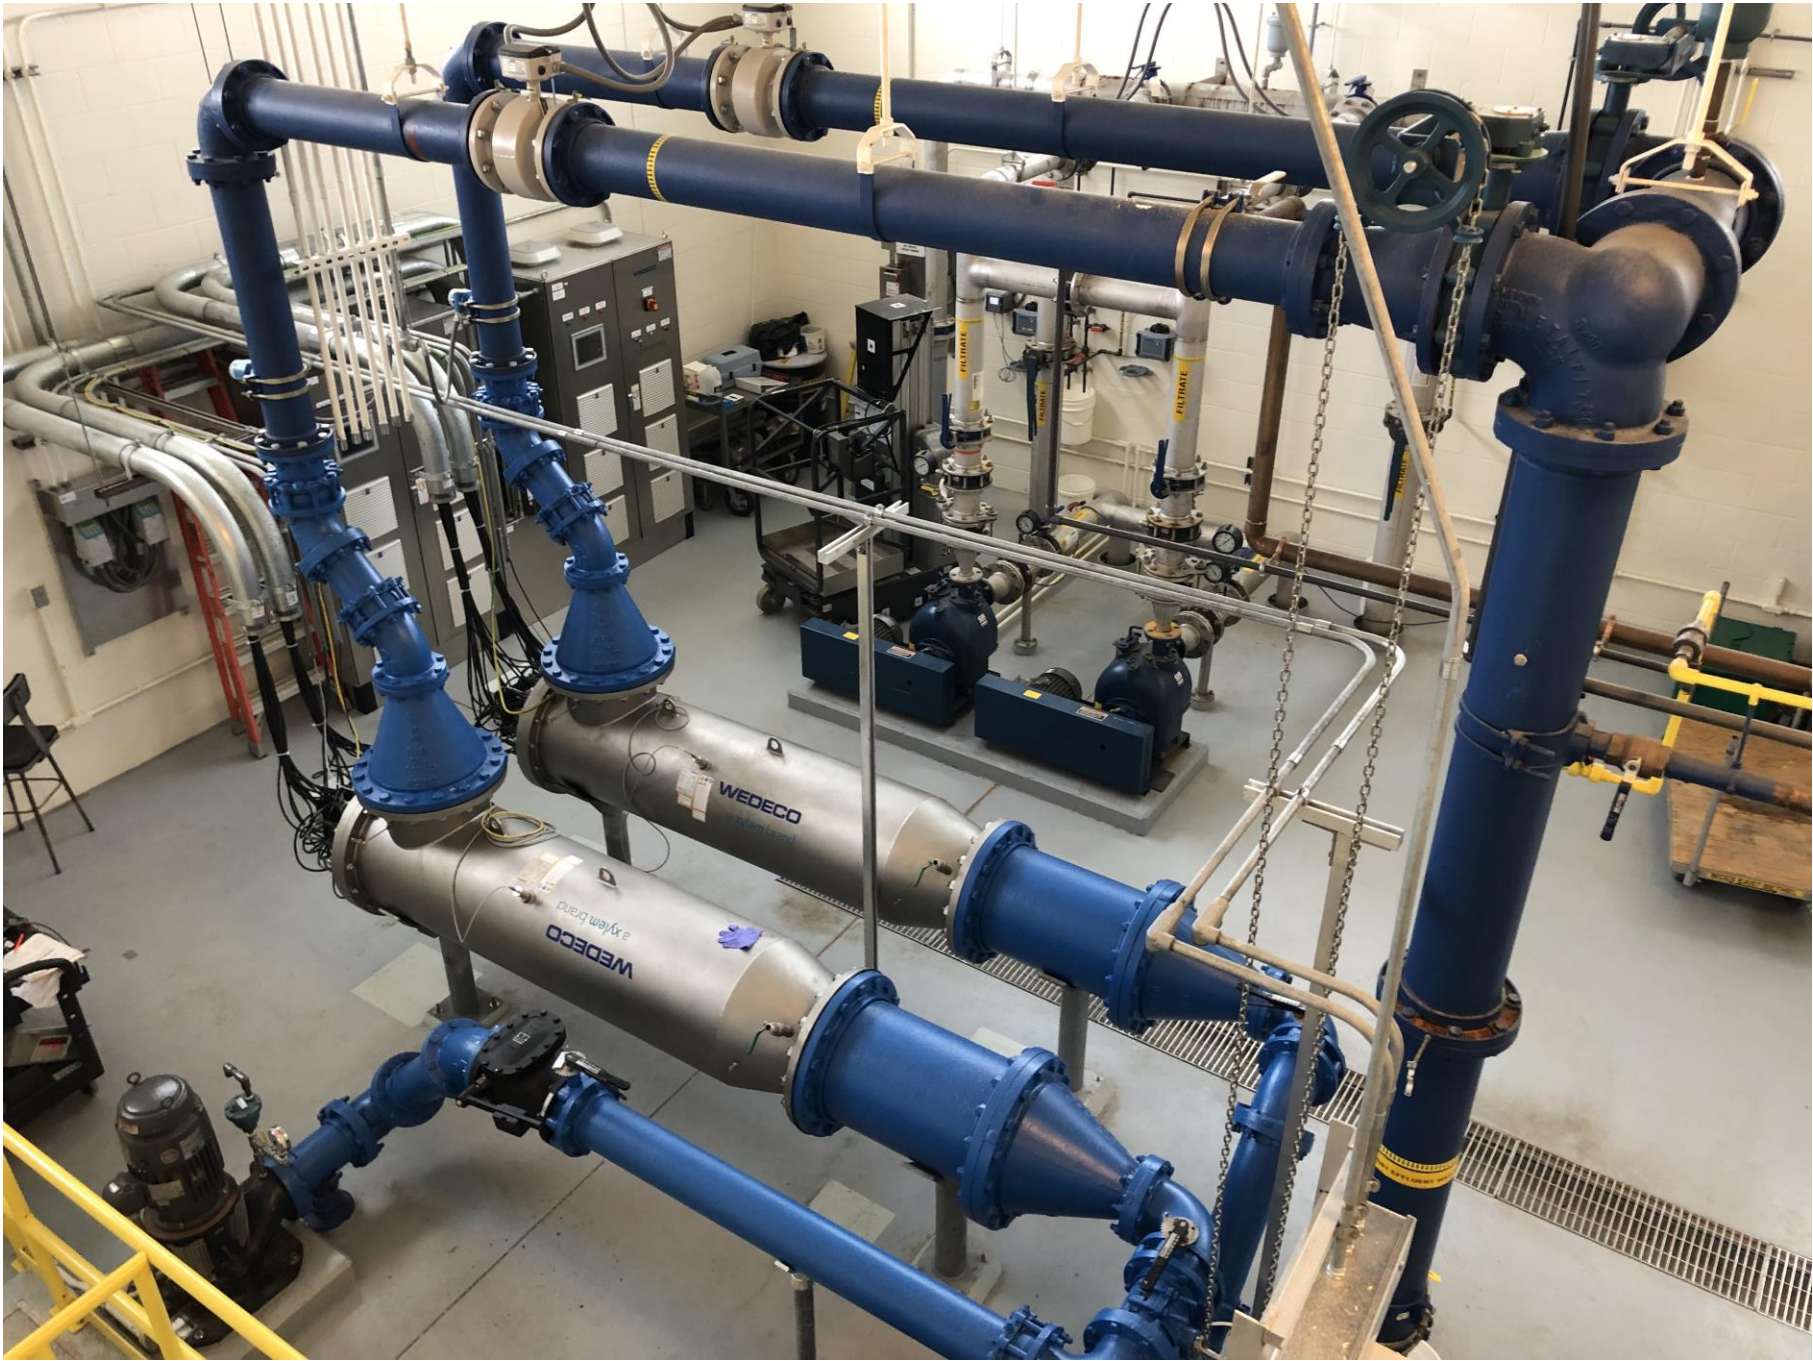
# Disinfection Upgrades

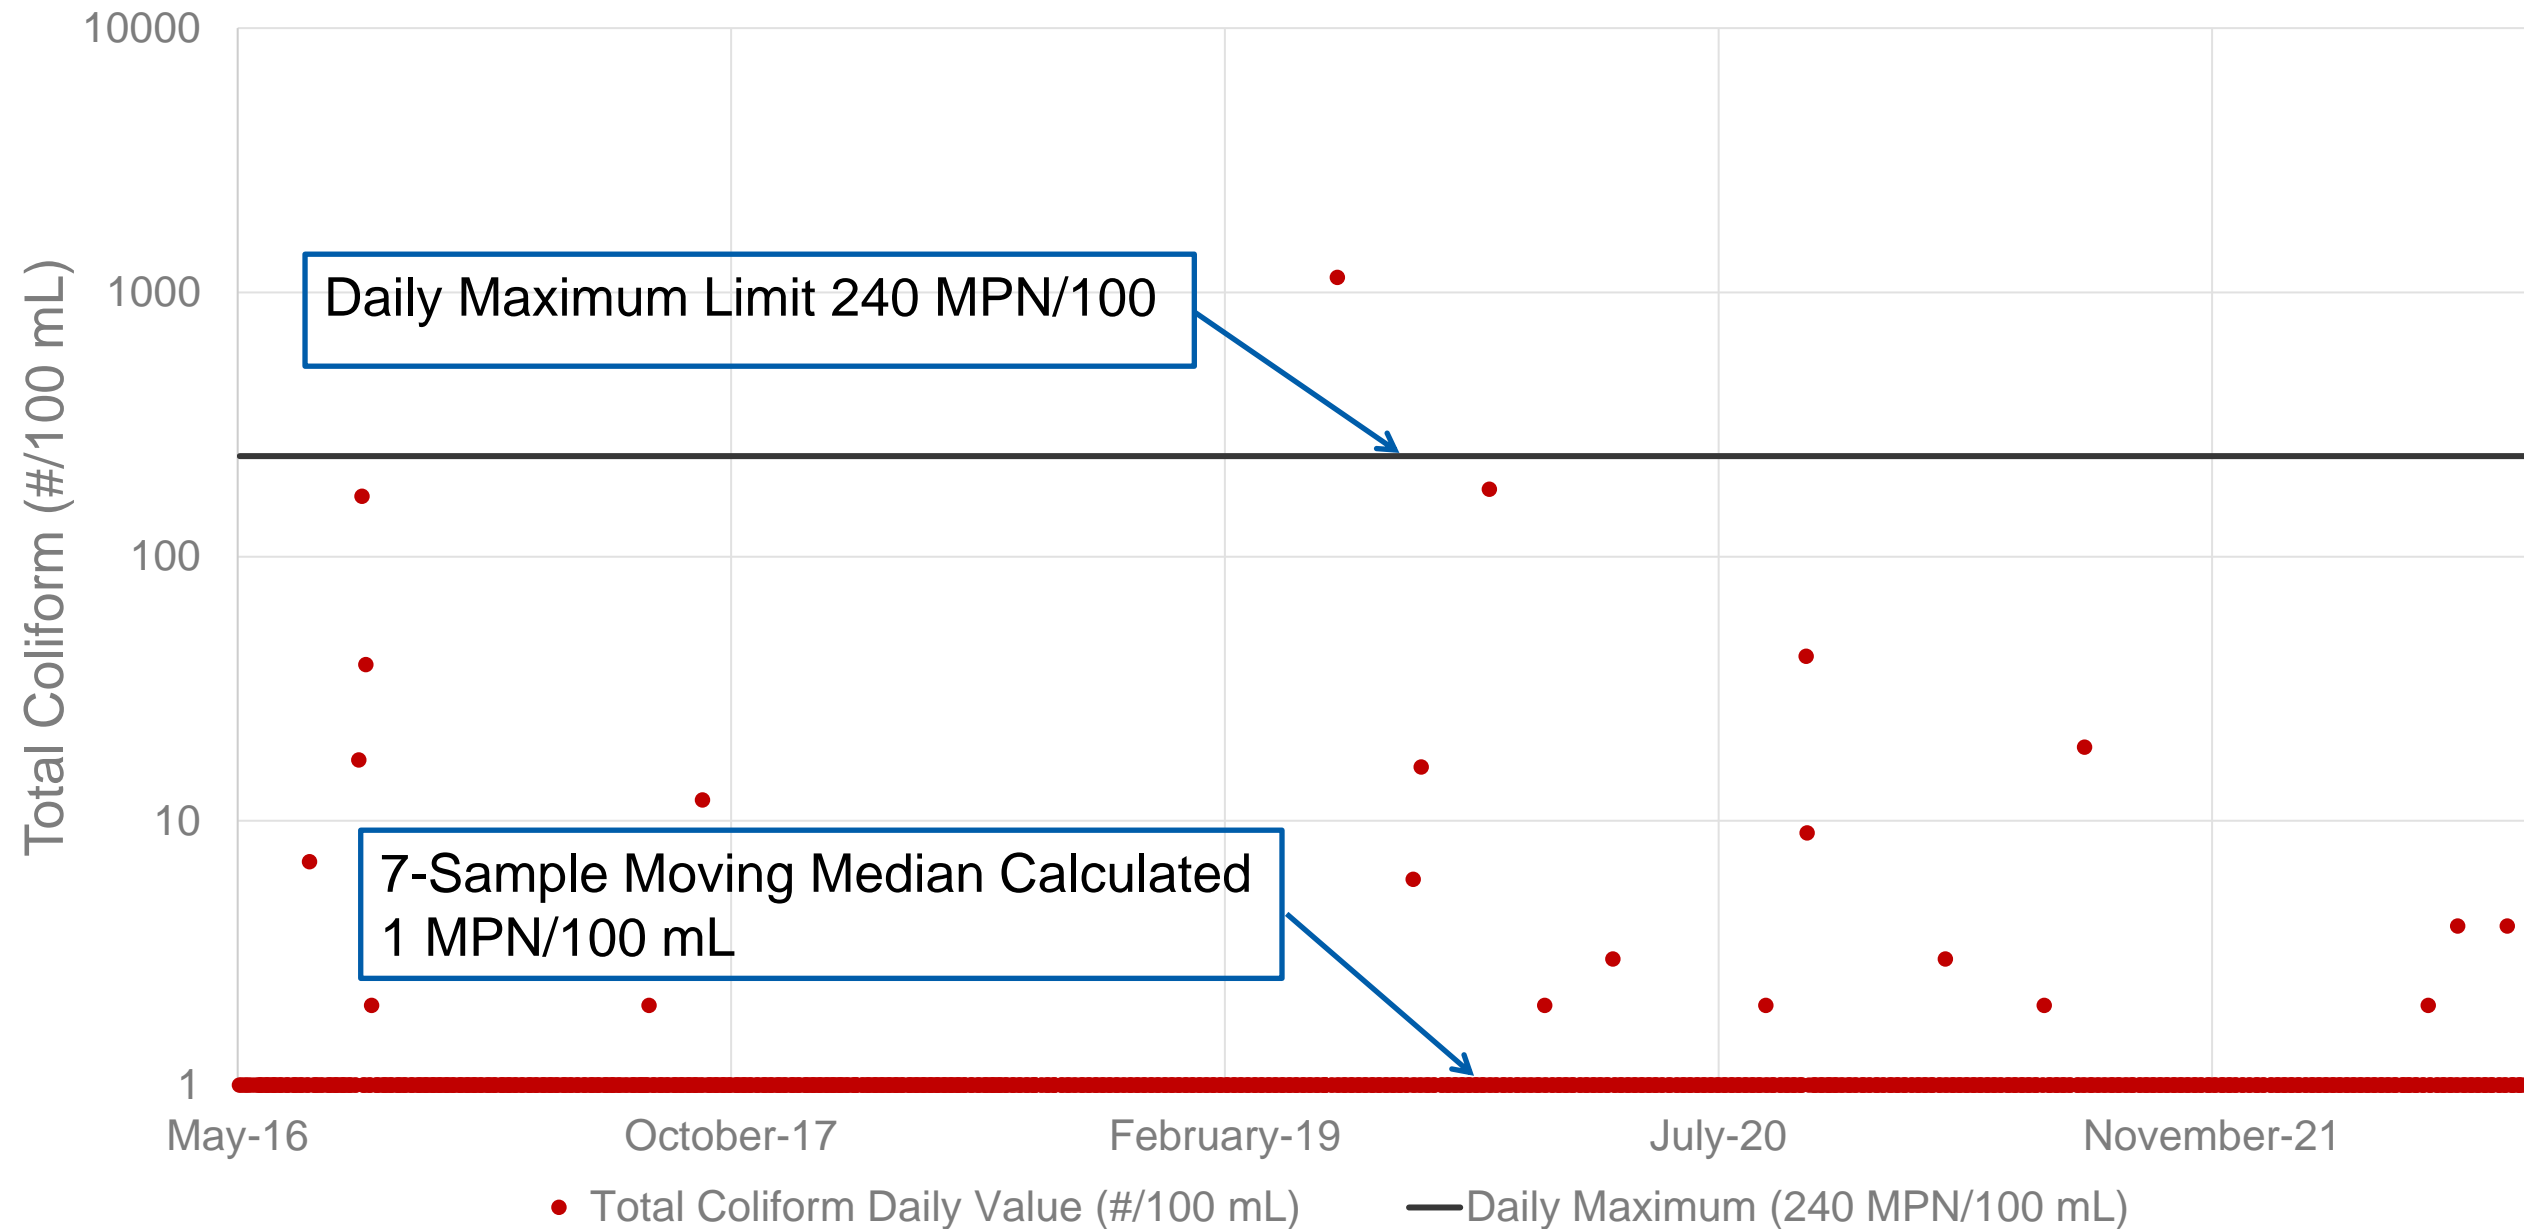
# Total Coliform, Daily Maximum Concentration

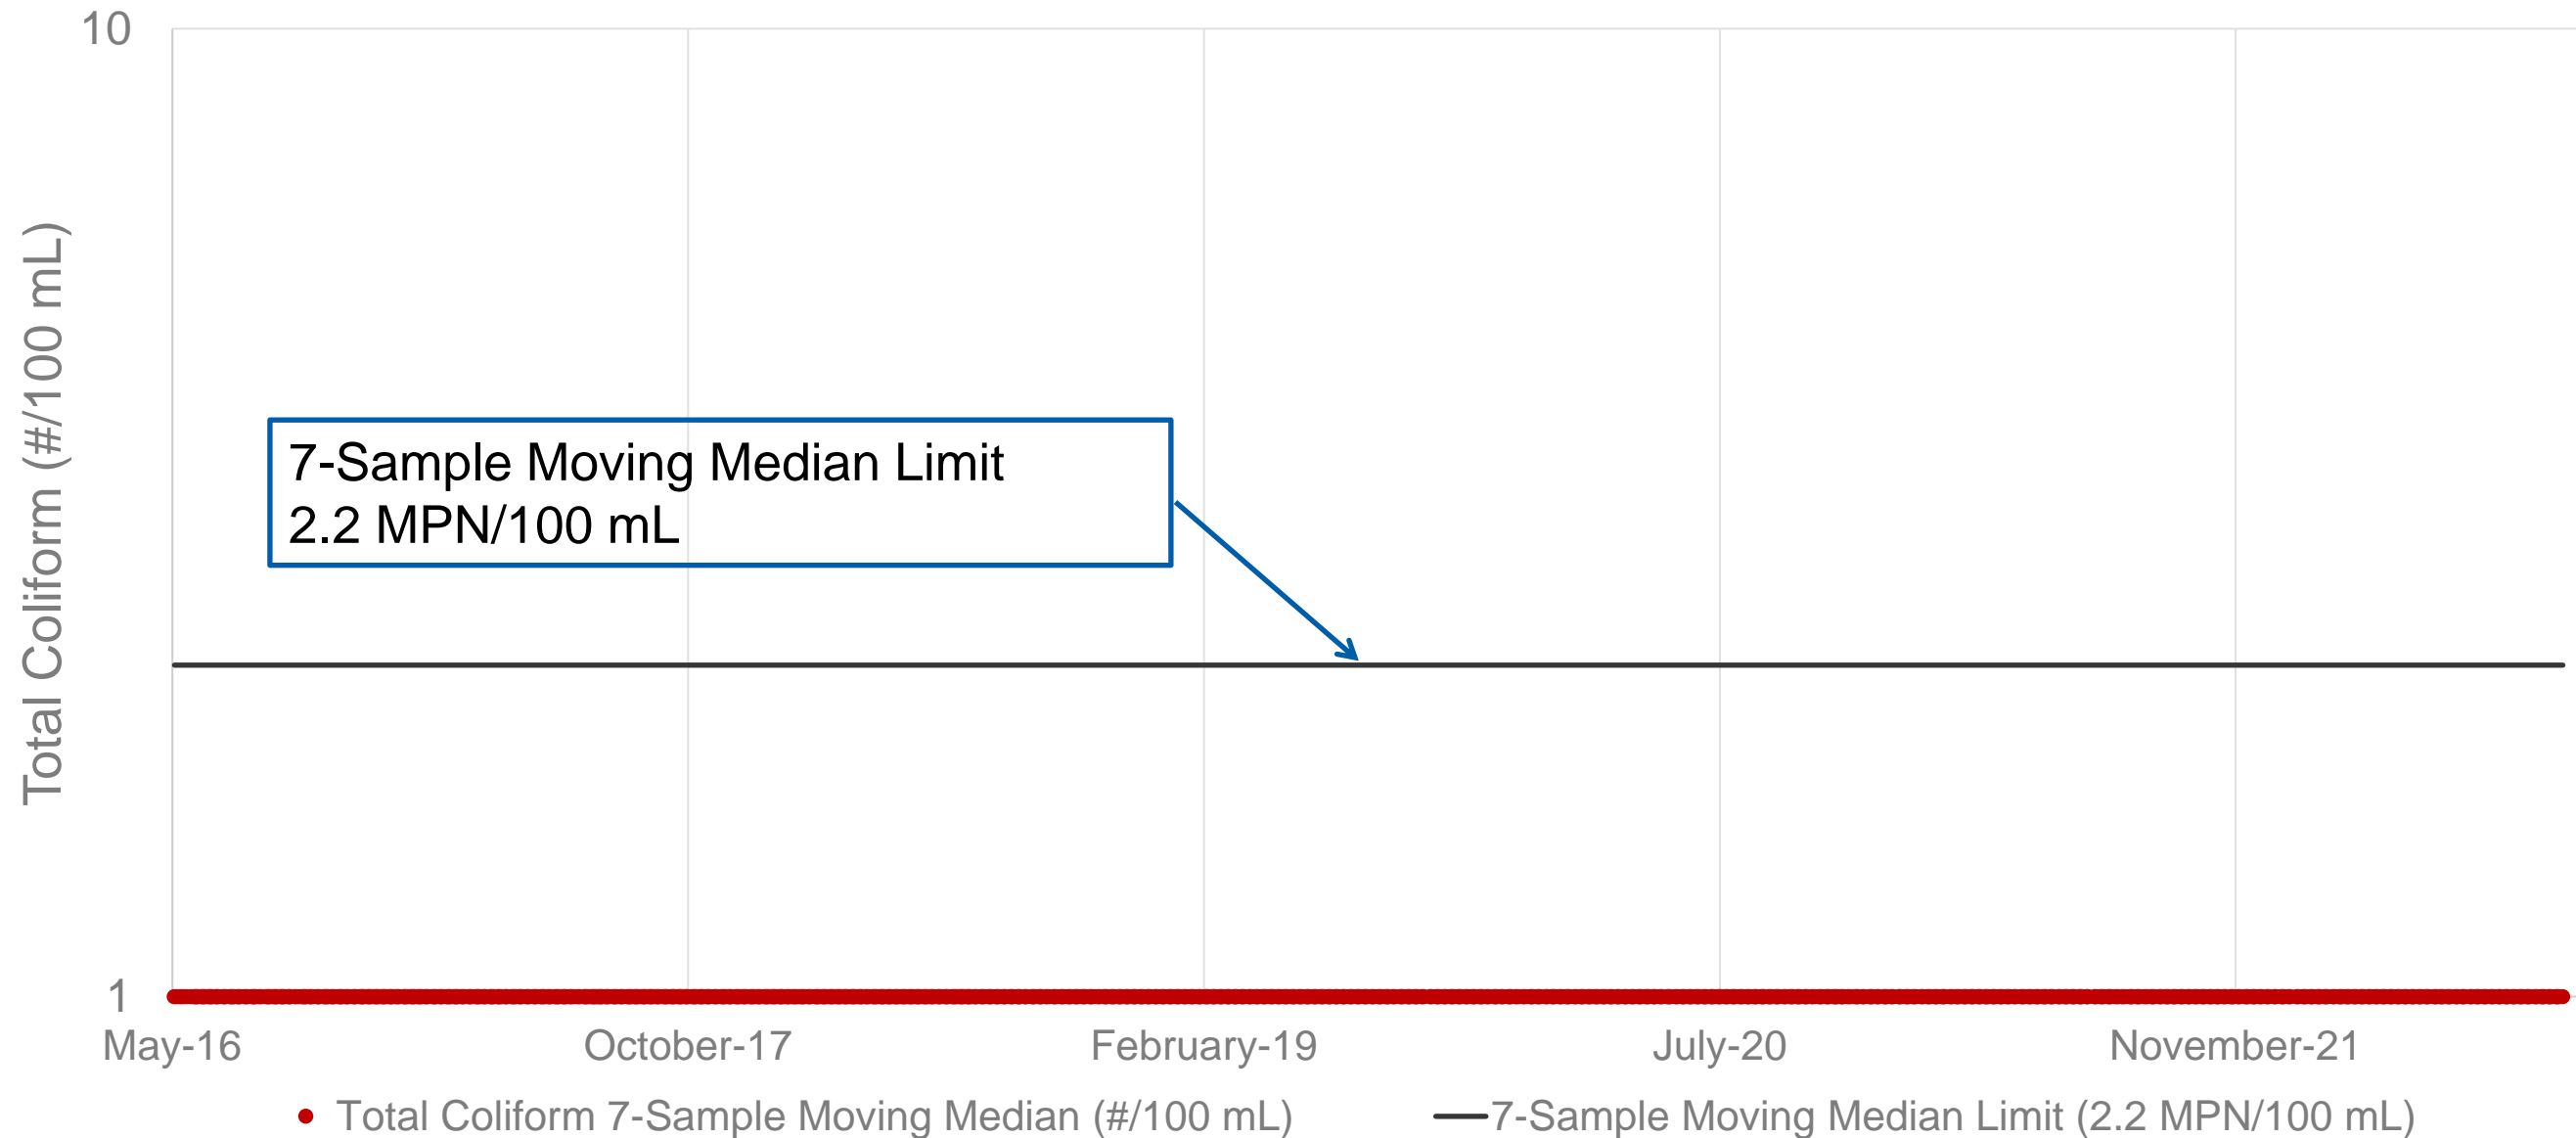
# Total Coliform, Moving Median Limit

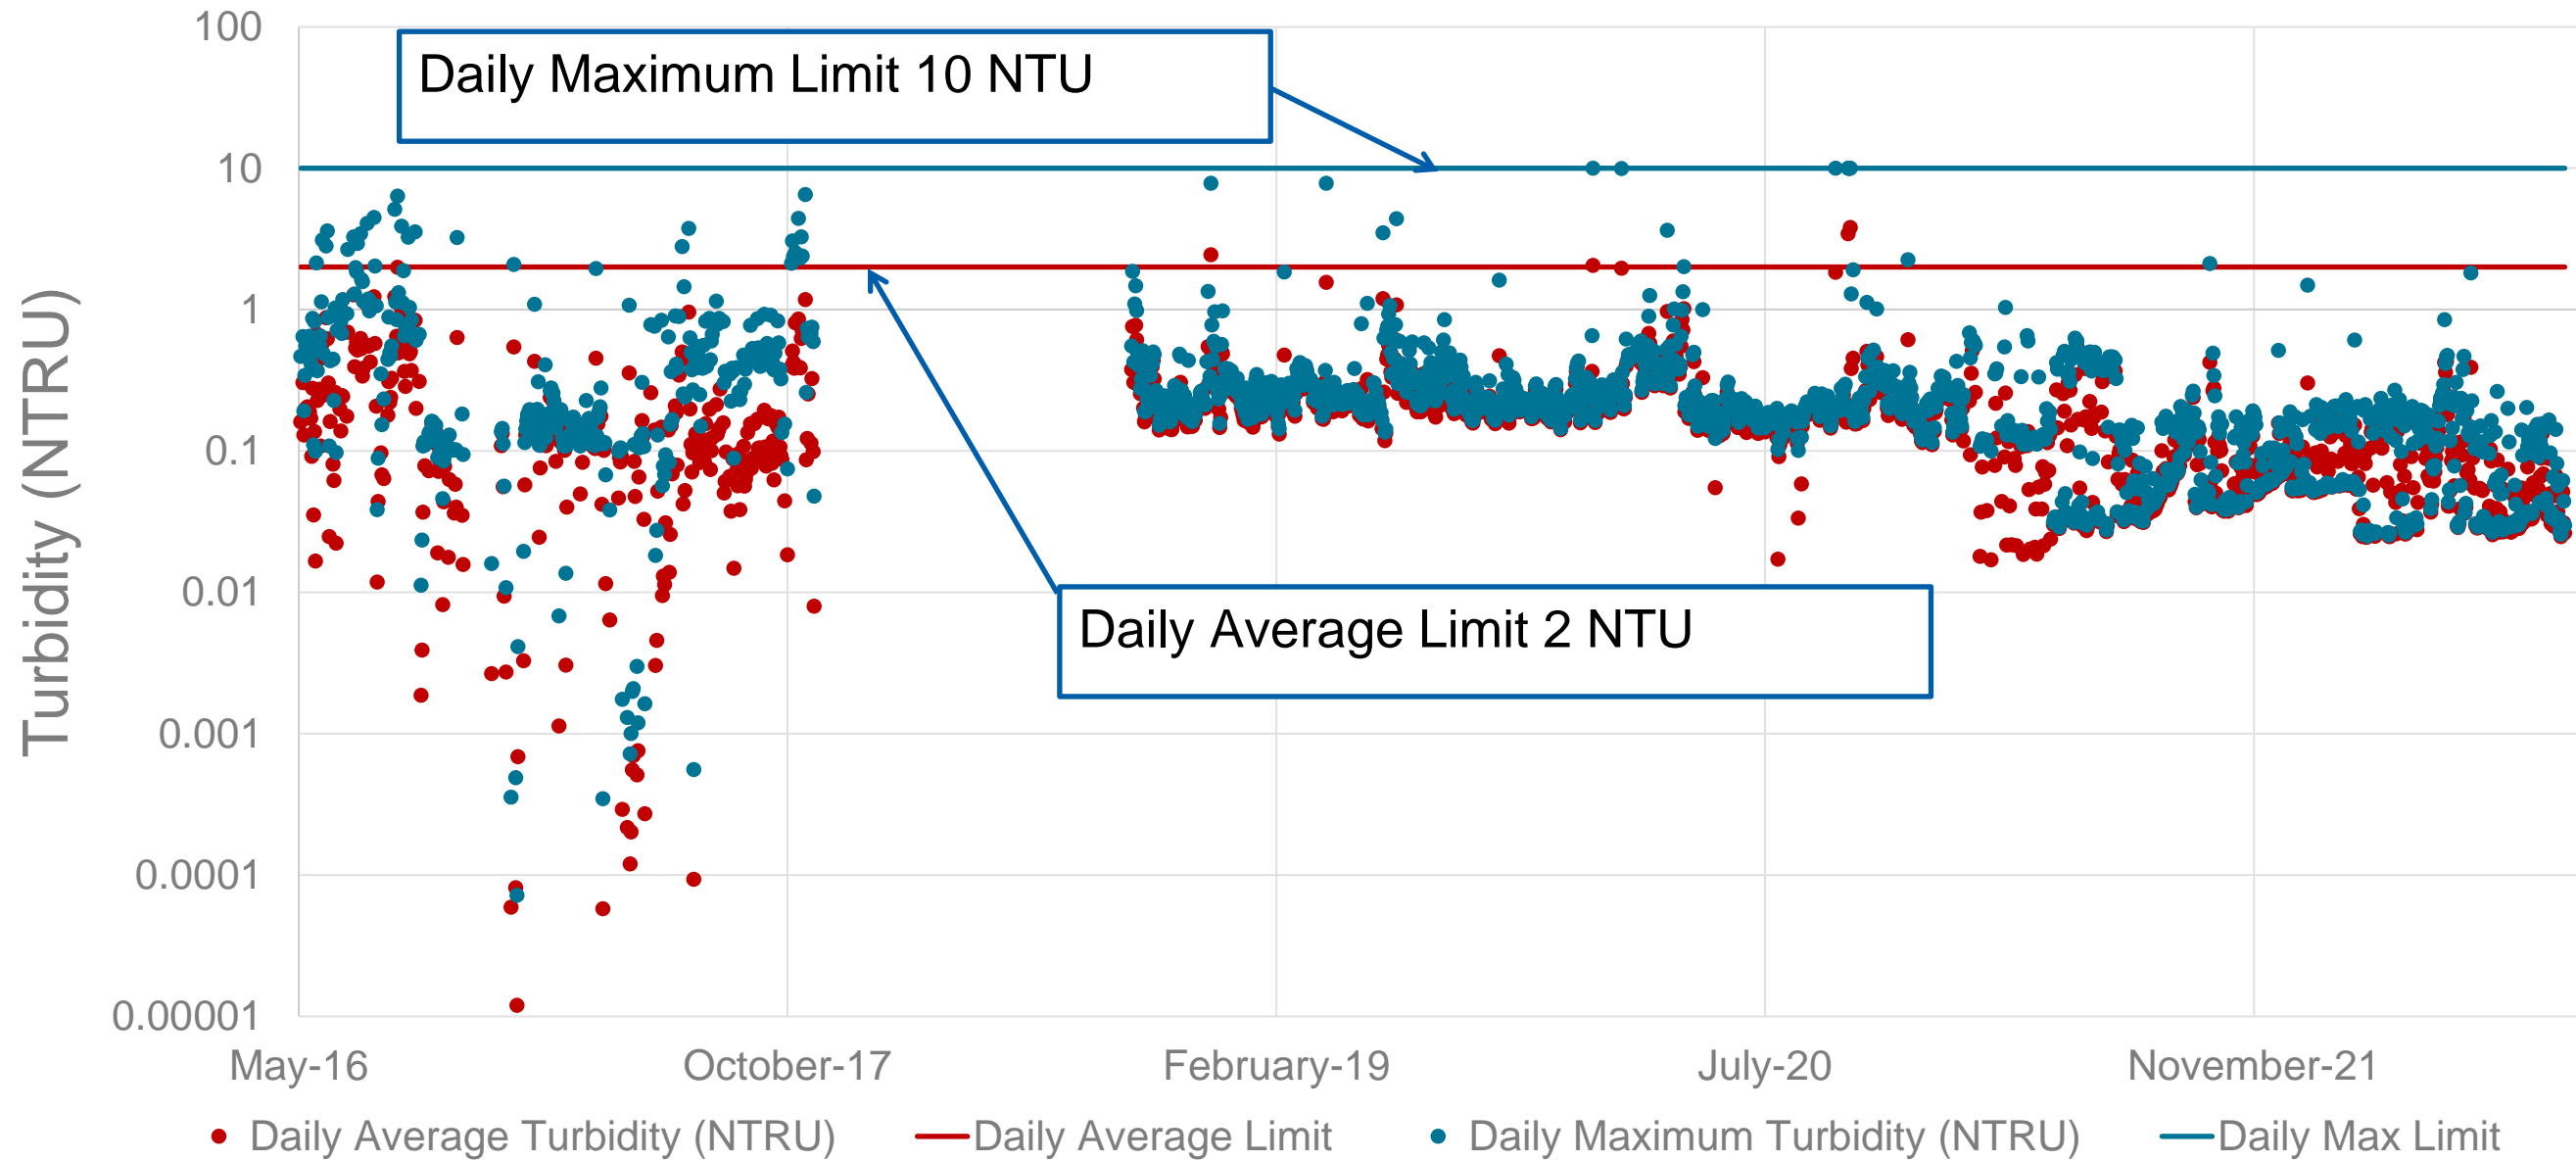
# Turbidity

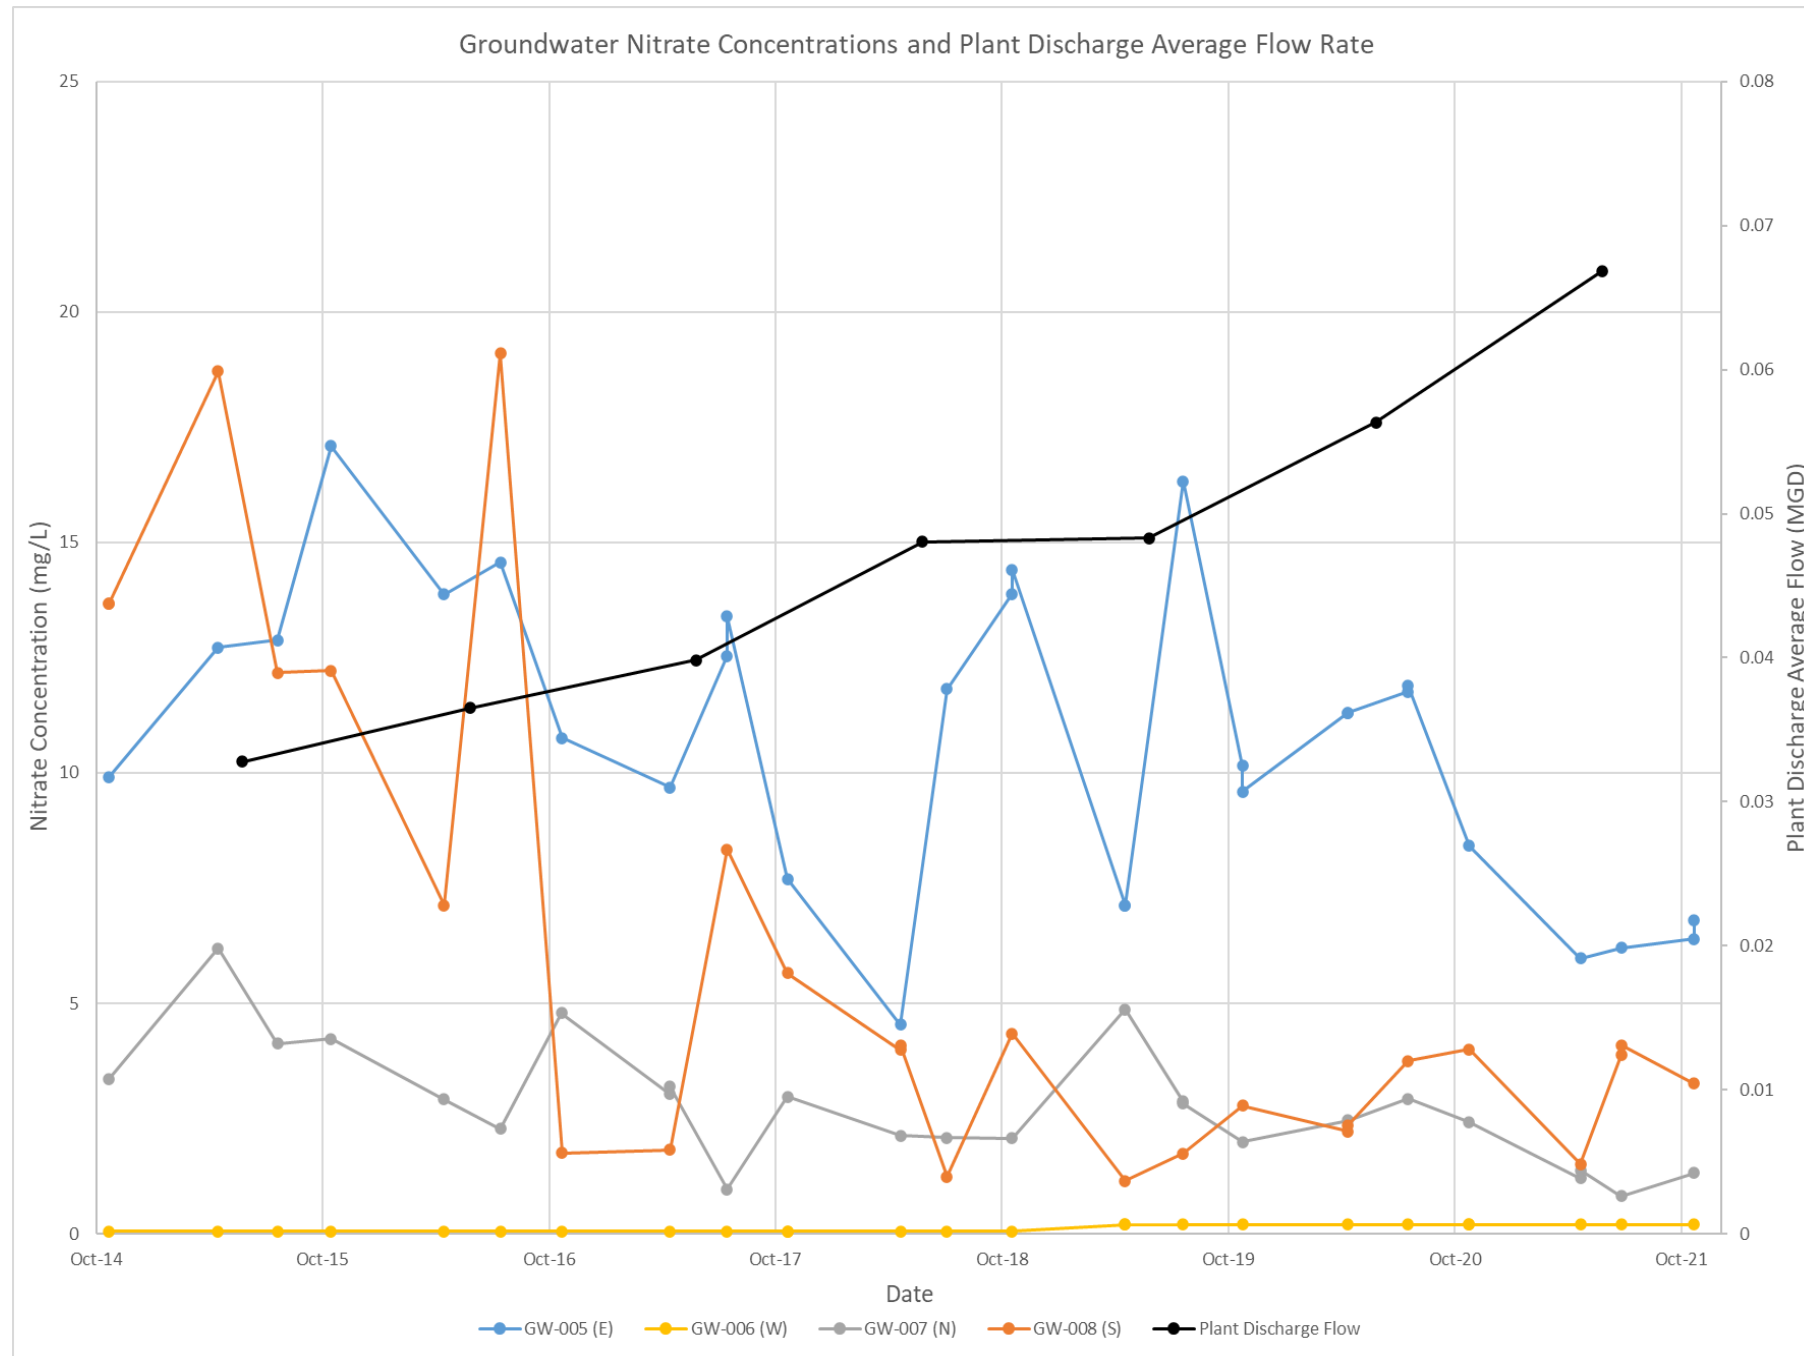
# Groundwater Nitrate Concentrations and Plant Discharge Average Flow Rate

- **Recent data show nitrate levels in the wells decreasing or consistent while plant flows increased over same period.**
  - This suggests the plant discharge is not the primary driver of nitrate levels in LAB E
