To:	Kathryn O'Brien		
From:	Tim Casey and Elliott B. Dick	Project:	Central Corridor Light Rail Transit
cc:			
Date:	November 6, 2008	Job No:	65891

Re: Transit train horns and bells simulation at Minnesota Public Radio

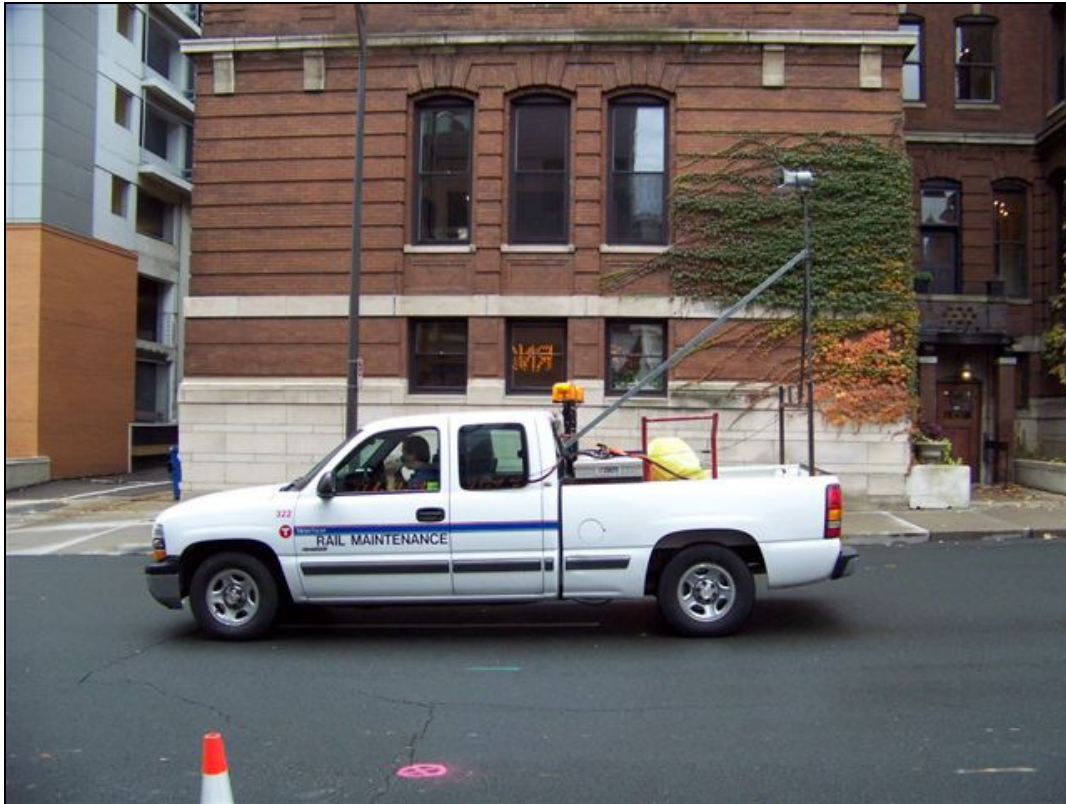
Figure 1

The accepted mock-up was constructed from spare parts of actual LRV audible warning devices, including a signal source box with adjustable levels, normally located behind a locked access panel in the LRV, and an Atlas-brand “wide-dispersion” horn, normally mounted atop the vehicle. The mock-up was mounted on a truck, and driven down Cedar Street along the planned CCLRT track alignment. A Hiawatha LRV operation trainer sat in the truck cab to trigger the sounding of horns, bells, or both, appropriate to standard operation of the vehicles. The photograph below shows the Metro Transit vehicle with the LRV horn; the horn control unit was in the back seat of the truck cab.

Metro Transit LRV Horn and Bell Simulation Vehicle
